CALSPAN ON-SITE AIR BAG DEPLOYMENT INVESTIGATION

CALSPAN CASE NO. 93-15

VEHICLE - 1992 FORD TAURUS

CALSPAN ON-SITE AIR BAG DEPLOYMENT INVESTIGATION
CALSPAN CASE NO. 93-15
VEHICLE - 1992 FORD TAURUS STATION WAGON
LOCATION [REDACTED]

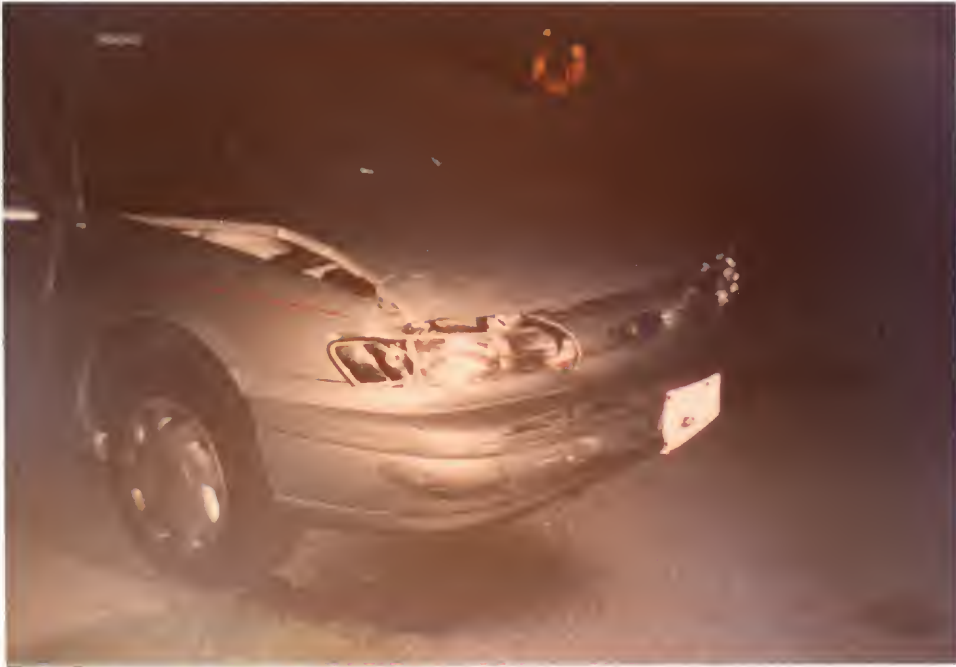
The full frontal area of the Ford Taurus impacted the right side area of the left turning vehicle #2. The Taurus sustained moderate frontal damage that was distributed across the full width of the vehicle. Based on impact configuration, resultant directions of force were probably within the 12 o'clock sector the Ford Taurus and within the # o'clock sector for the struck vehicle #2. As a result of the crash, the Taurus underwent a sufficient longitudinal deceleration which deployed the dual air bag SRS. The velocity change was estimated at 18-21 KPH (11-13 mph).

Frontal Damage To The Ford Taurus

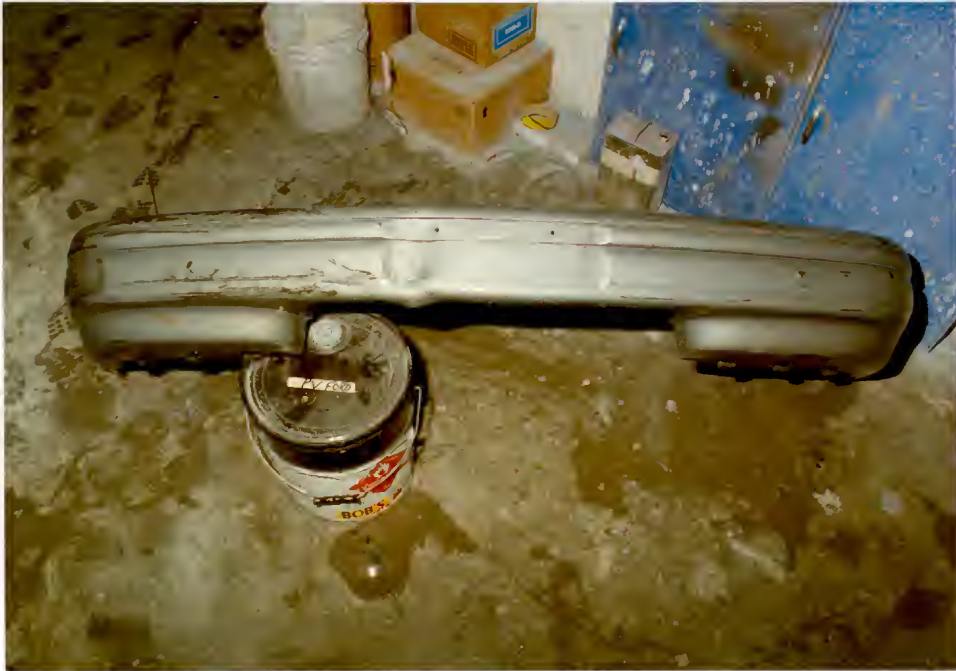
Damaged Bumper Facia

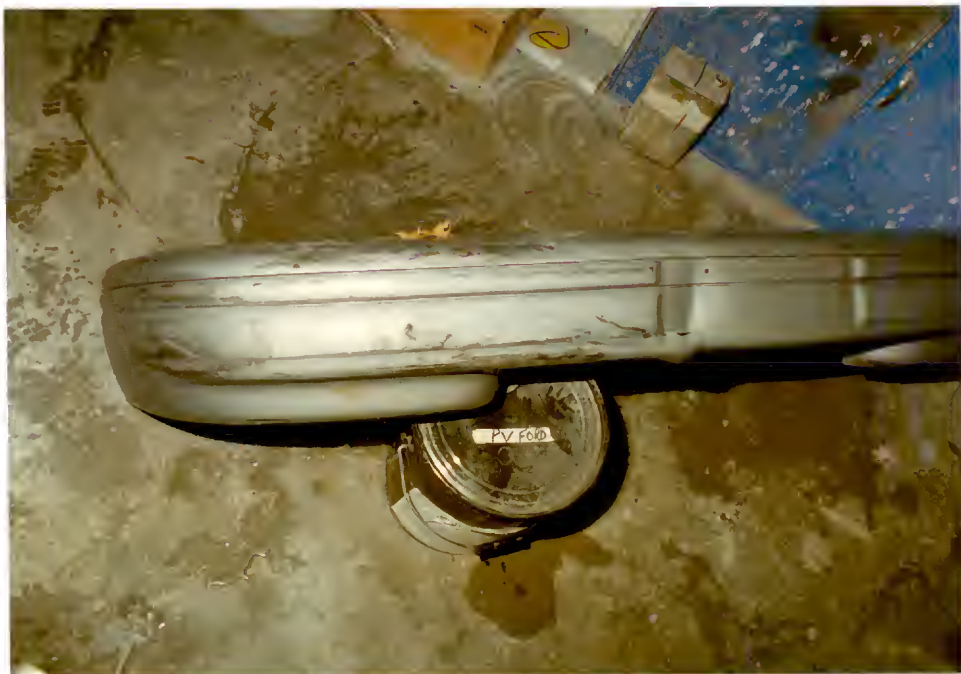
Direct Contact Damage To Right Side Of Bumper Facia

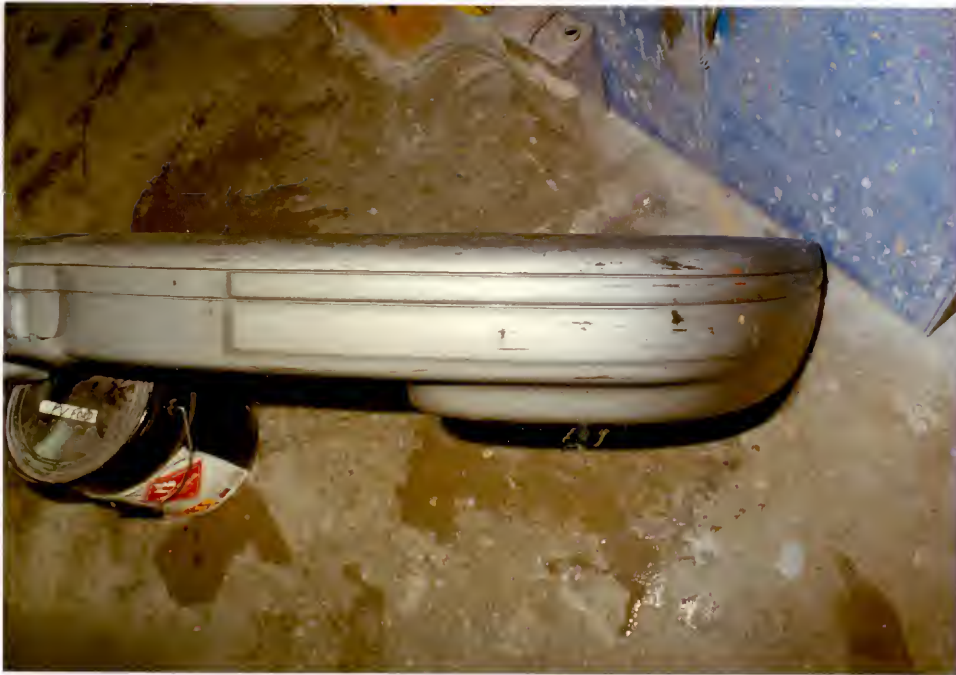
Direct Contact Damage To Left Side Of Bumper Facia

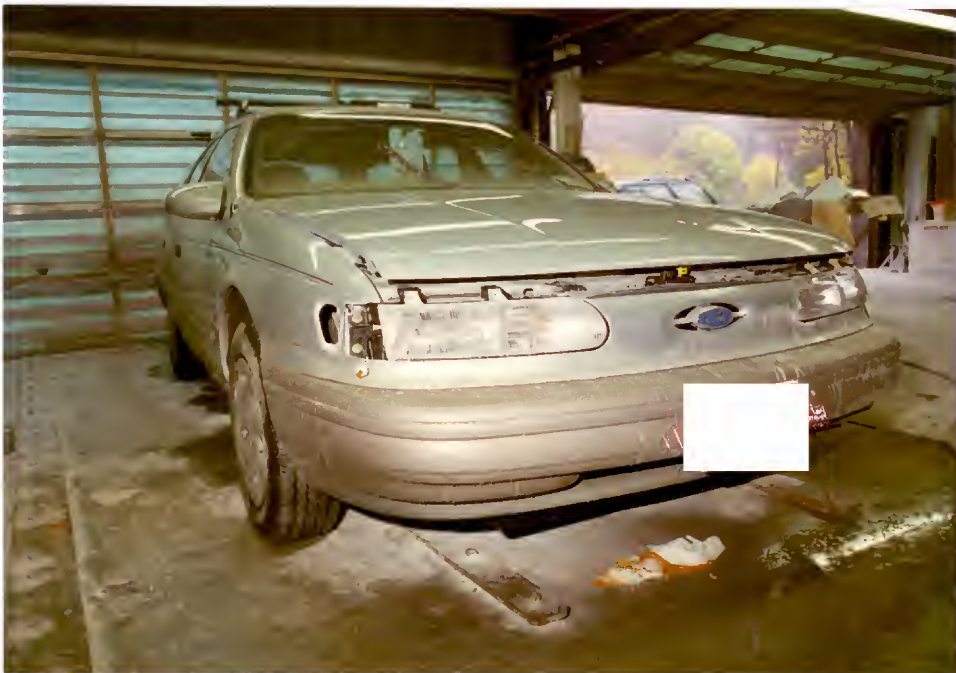
At the time of our inspection, the exterior damage to the Ford Taurus had been repaired. The body shop reported that they had replaced the front bumper, both bumper energy absorbing units (EADs), the header panel, hood, and the air conditioning condenser. In addition, the body shop repaired the right front fender and straightened the radiator support panel and both front frame rails. They also replaced the front mounted crash sensors for the SRS. The total repair cost was \$5,783.

Frontal View Of The Repaired Ford Taurus

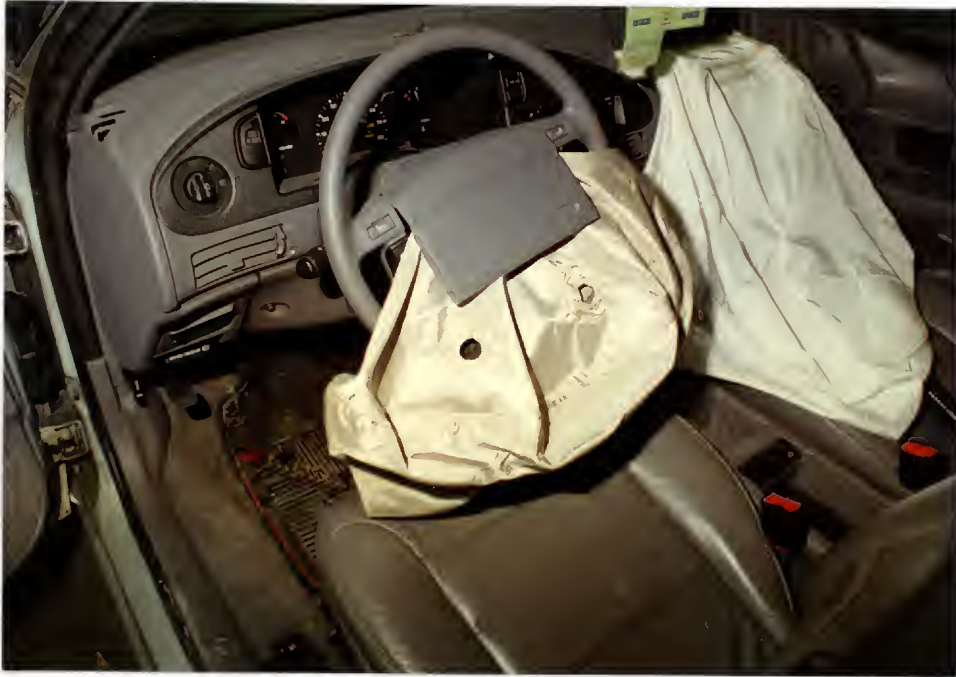
The driver's side air bag system deployed in a typical sequence from the steering wheel mounted module assembly. The module was contained within an offset (vertical orientation) four-spoke steering wheel rim with the cruise control buttons located on each side of the module. The module cover flap opened at the designated tear points in an H-configuration. The large upper flap measured 20.3 cm (8") horizontally x 12.4 cm (4.8") vertically while the smaller lower flap had respective measurements of 20.3 cm (8") x 3.5 cm (1.375"). Both cover flaps were approximately 8mm (5/16") in thickness. The upper module cover flap had an identification number [REDACTED] molded into the inside surface. There was no damage to the flaps.

Driver's Side Air Bag Vent Ports And Upper Module Cover Flap

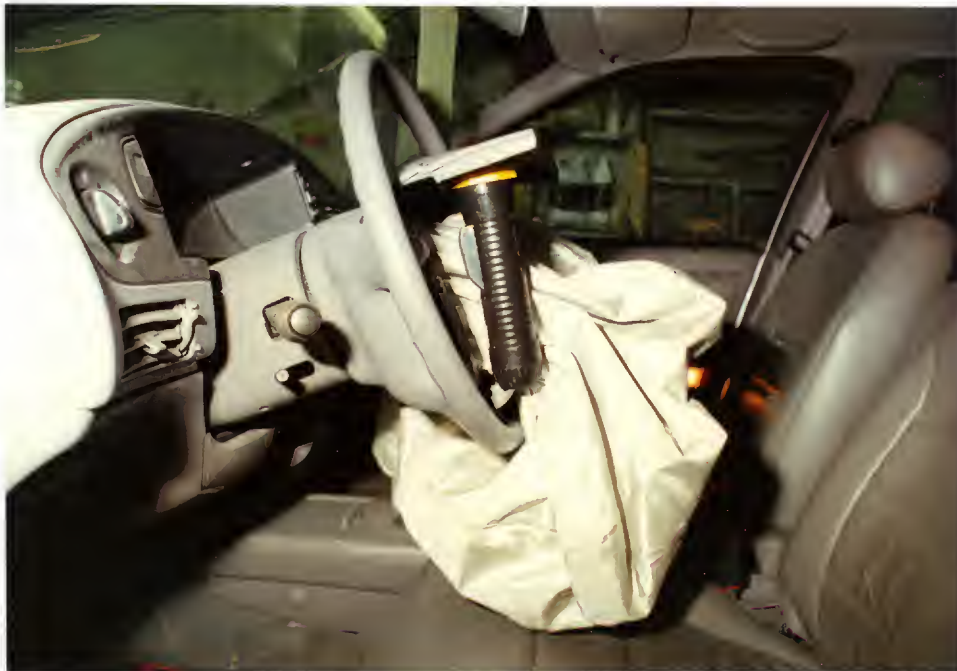
Perpendicular View Of The Driver's Side Module Cover Flaps

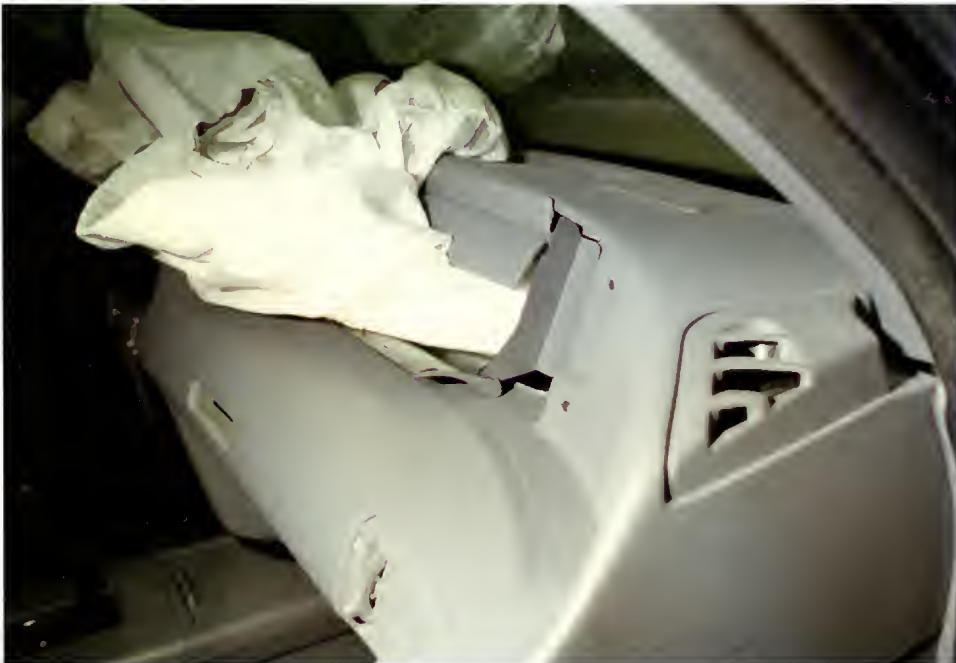
The passenger side air bag deployed from the module that was mounted into the upper right instrument panel of the Ford Taurus. The module cover flaps were positioned in a vertical orientation and opened in an H-configuration. The upper flap was rigid and remained in a vertically orientated (closed) position. The flap was 31.1 cm (12 5/16") wide and varied in height, 7.5 cm (2 15/16") at the left edge, 7 cm (2.75") at the center, and 6 cm (2 3/8") at the right edge. The lower module cover flap was hinged at the bottom and opened fully to 90 degrees. The flap was similar in width to the upper and was 6.5 cm (2.5") in height at the edges and 6.7 cm (2 5/8") at the center point. Both module cover flaps were approximately 3 mm (1/8") in thickness.

Perpendicular View Of The Passenger Side Air Bag Module Cover Flap

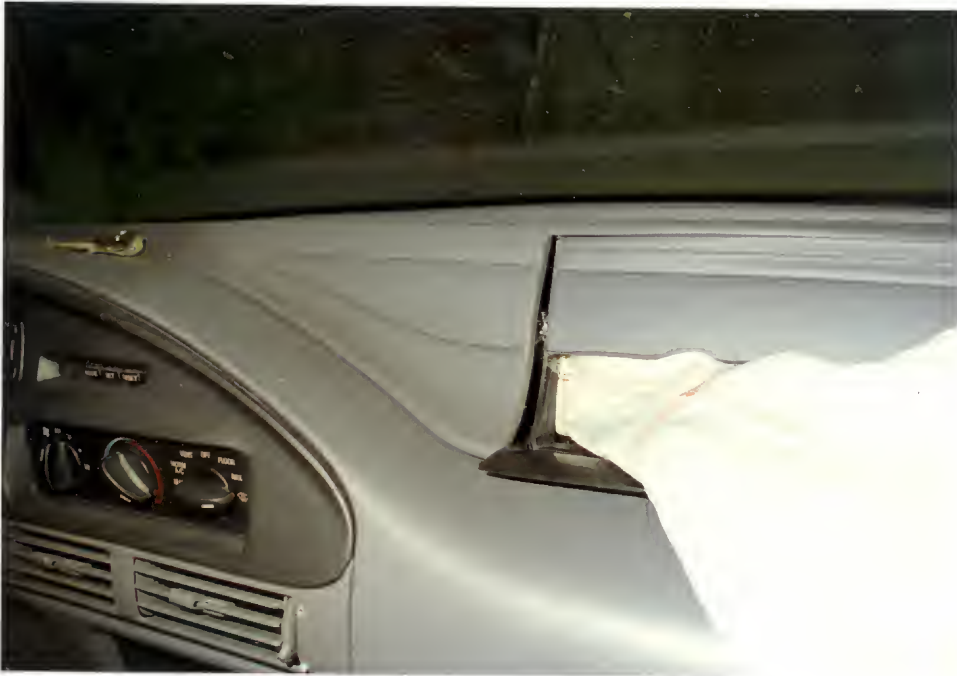
Both trim panels appeared to have been dislodged by the module cover flaps as the passenger side air bag deployed. The three spring clips for the left side trim panel had disengaged from their mounting holes and the panel was found resting on the upper/mid instrument panel juncture. The right side trim panel had completely separated from the instrument panel and was found by the driver and her husband on the right front floor, adjacent to the outboard corner of the bucket seat cushion. In addition to the separation of the trim panels, a small rigid plastic TAURUS name plate disengaged from the right mid instrument panel located between the glove box door and the passenger air bag module assembly. The 9 cm (3 1/2") x 2 cm (13/16") name plate came to rest on the right front floor area of the vehicle.

Disengaged Trim Panel Adjacent To The Left Side Of The Passenger Air Bag Module

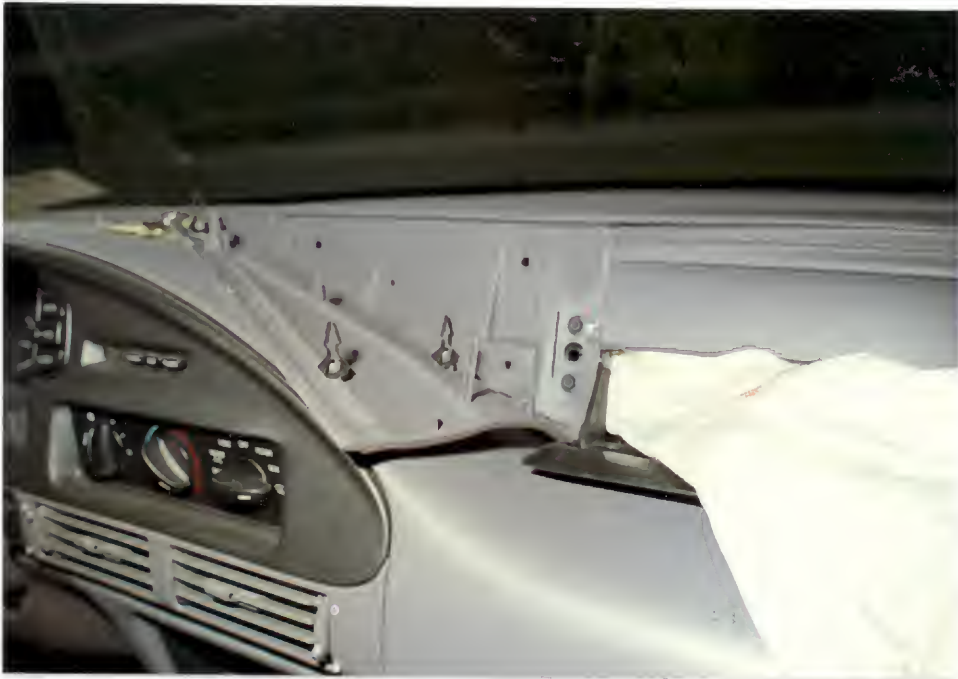
Spring Clips And Mounting Holes

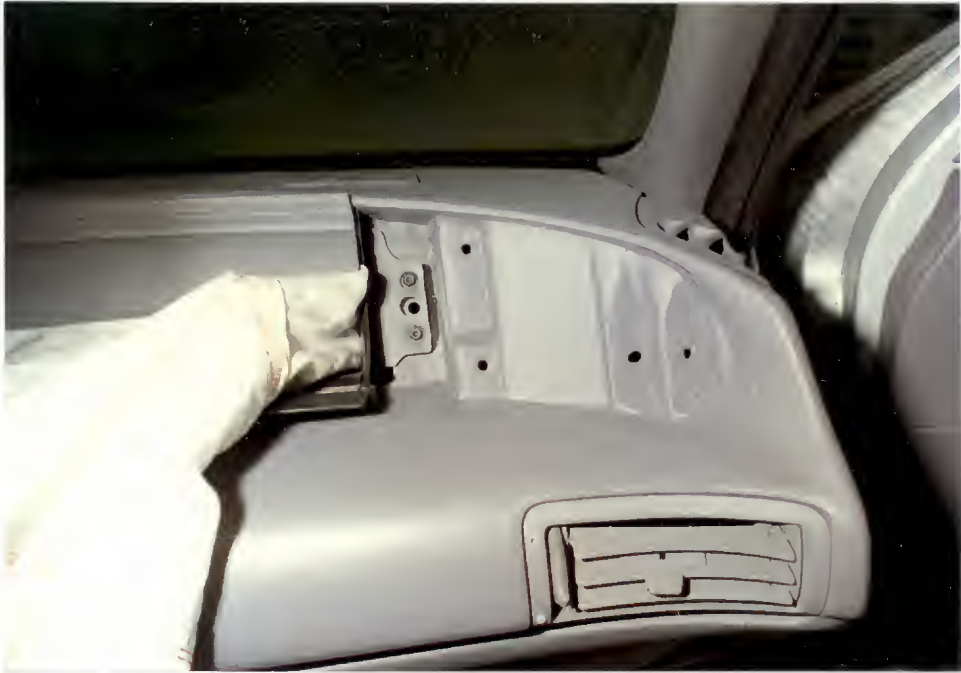
Disengaged Right Side Trim Panel

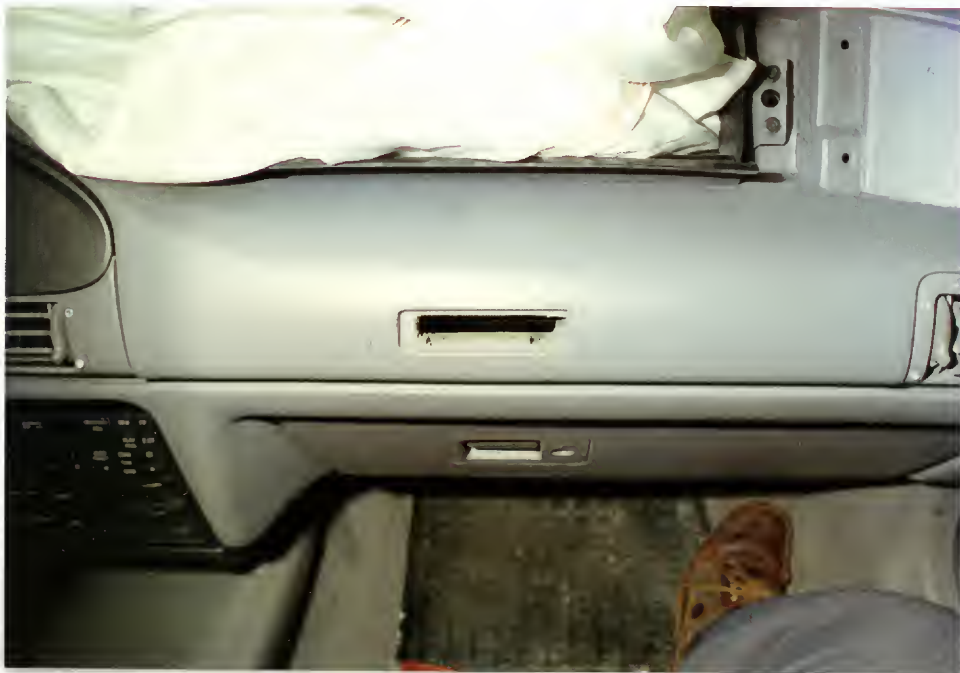
Disengaged TAURUS Name Plate From Mid Panel

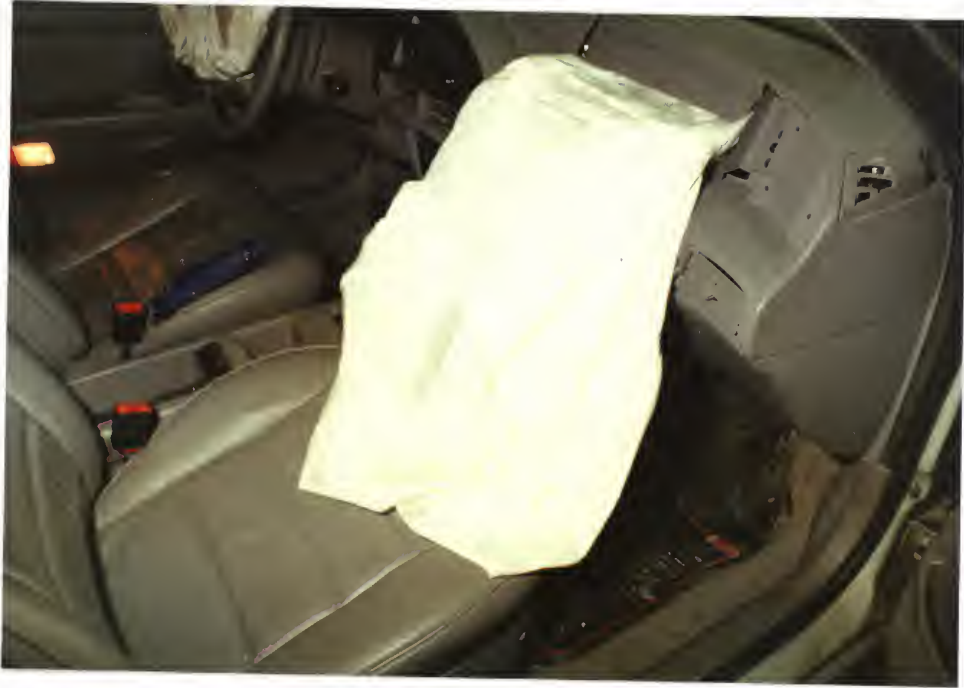
The air bag fully extended from the module assembly and was constructed of three major sections of a woven nylon fabric. There were no internal tethers or neoprene type liner within the passenger bag. A large continuous section of the bag formed the top, face, and bottom surfaces while individual sections formed both side panels. All seams were internal and were sewn with stitching similar to that of the driver bag. Two large 6.4 cm (2.5") diameter vent ports were located on the left inboard side surface of the bag. The vertically orientated ports were located 47 cm (18.5") outboard of the upper instrument panel.

Deployed Passenger Side Air Bag

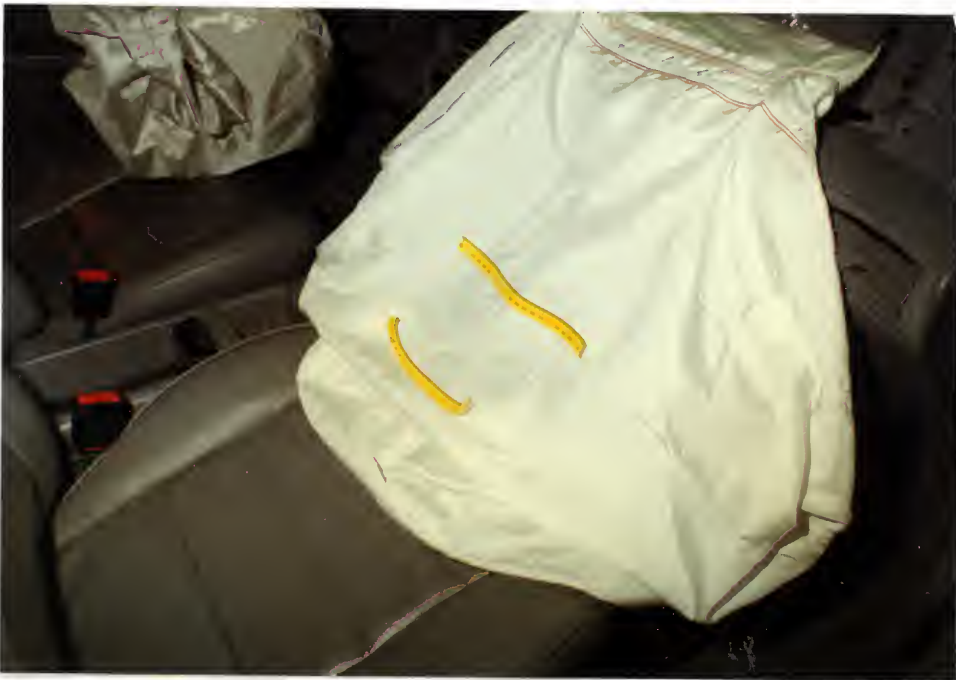
Fabric Snags In Passenger Side Air Bag

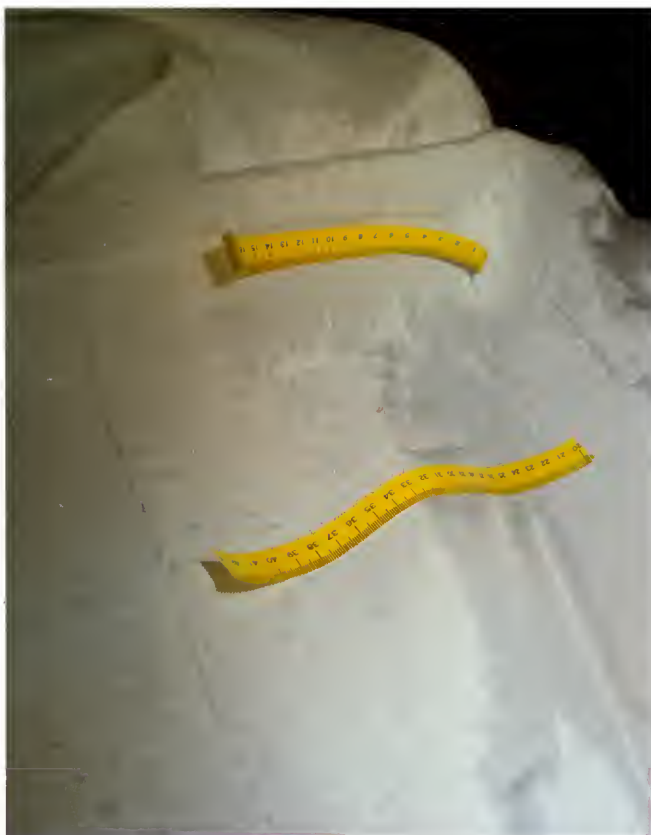
Closeup View Of The Fabric Snags
